Water Resources Department
North Mall Office Building
725 Summer Street NE, Suite A
Salem, OR 97301-1271
503-986-0900
FAX 503-986-0904

February 18, 2014

Re: Silver Creek Dam (S-66) – Inspection Summary

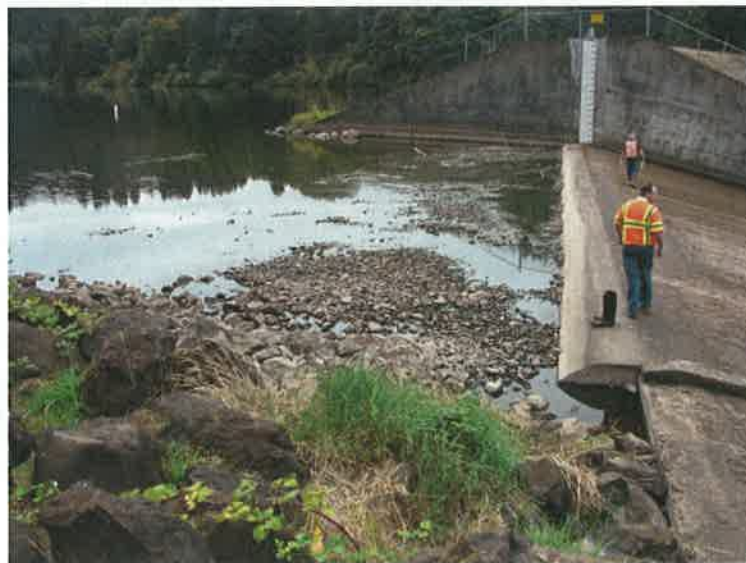
Spillway control section

There is nothing apparent that would affect capacity of the emergency spillway. The spillway is clear of obstructions and shows no signs of erosion that might affect its safely passing flood flows. The reservoir level was 423.4 feet on the staff gage when inspected. Minimum recent freeboard was 13 feet, which is very good.

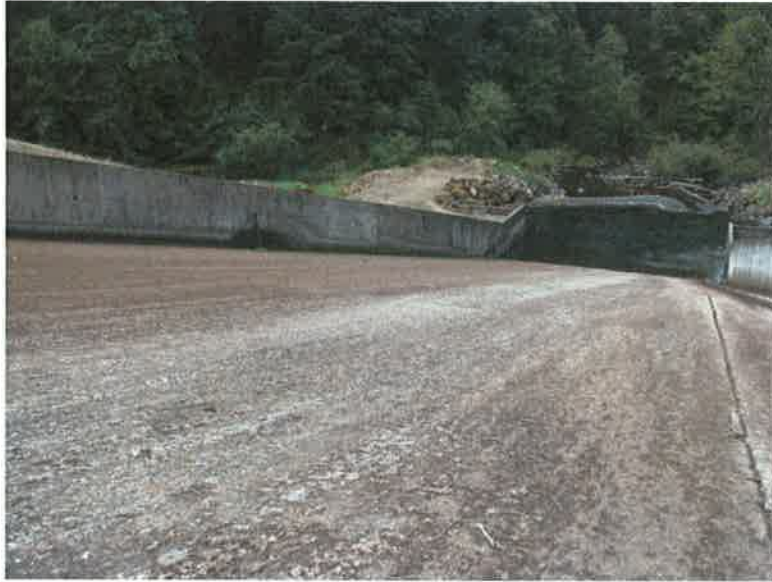
Spillway discharge channel

The stilling basin and base of spillway were repaired last year, and the repairs should bring the energy dissipation function to near its designed condition. As of this inspection, these repairs were not yet tested by a high flow event.

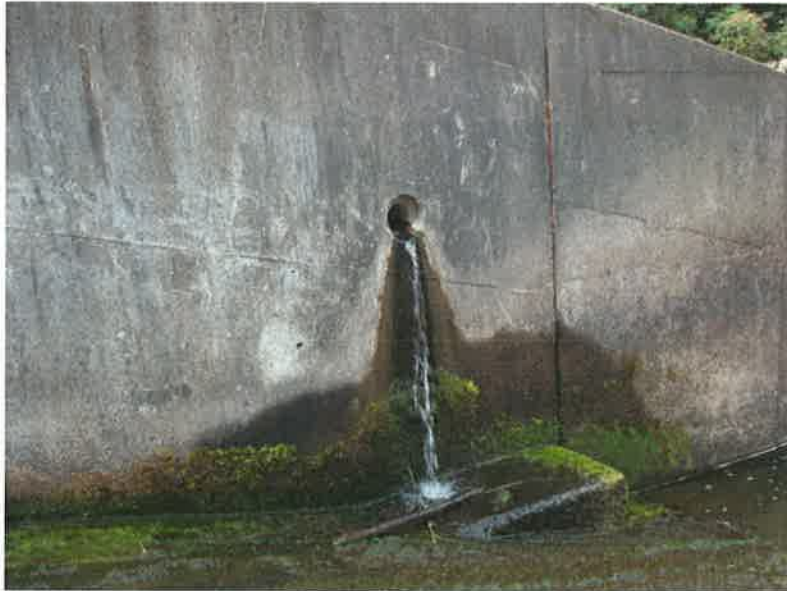
Spillway drain

Spillway drains three and six were the only two drains with significant flow for this inspection. These are the drains that most commonly flow. Flow from drain three was 9 gallons per minute, and flow from drain six was 6 gallons per minute. All flow was clear.

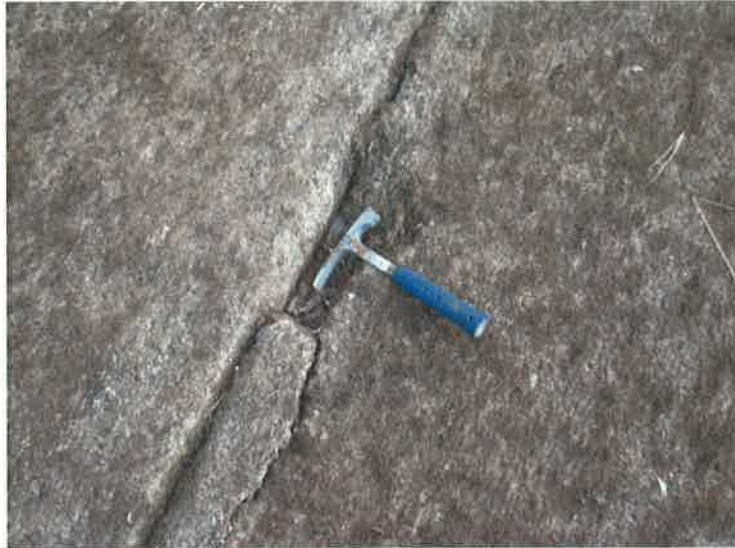
Concrete loss between spillway slabs

As was first observed during the 2012 inspection, a hammer strike on the concrete spillway slab results in hollow sounds, especially around a few of the joints. There is also delamination and exfoliation cracking around a few of the joints, as shown in the photo above. We discussed the need for a few core holes through the slabs while we were on site, in order to determine the cause of the isolated voids under the slabs.

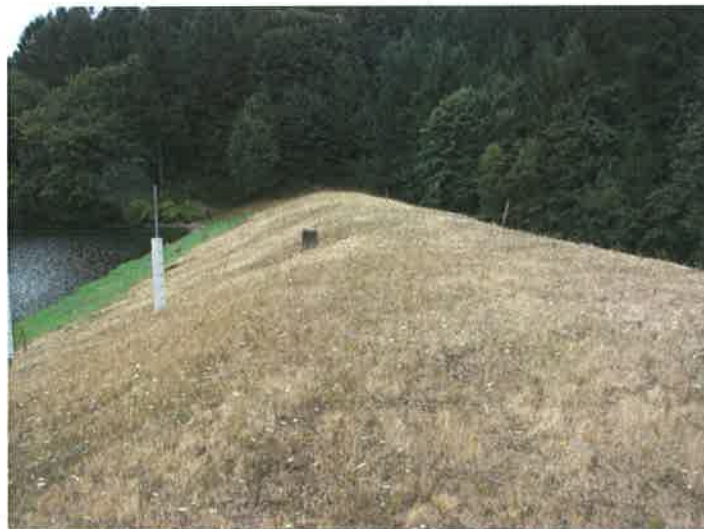
Crest and upstream face

The embankment shows no signs of settlement, instability, or internal erosion. The crest is wide and shows no signs of settlement. This dam has a well maintained cover of grass and other non woody vegetation. The grass cover on the dam now effectively reduces surface erosion and provides very little cover for burrowing animals. Over the last three years, maintenance of the embankment has been superior.

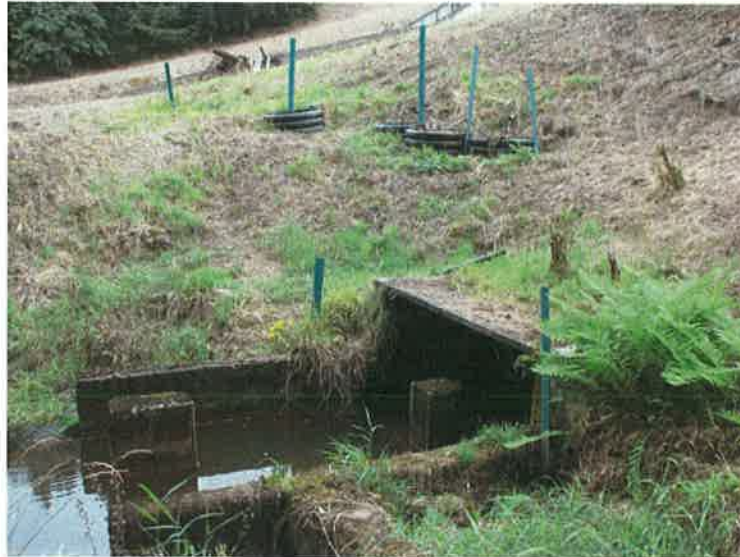
Low level conduit discharge and toe drains

The conduit did not close completely during this inspection. In review of the inspection files, the 2001 OWRD inspection, the report included the following. "To gain access to the 42" diameter outlet conduit through the dam, city personnel installed a cofferdam across the stilling basin and pumped the accumulated water into the downstream channel. The biggest obstacle during the inspection was the amount of leakage (estimated 2 cfs) that traveled down the pipe and into the stilling basin. It was necessary to use three portable pumps to effectively drain the stilling basin and thus expose the downstream invert of the 42" outlet conduit." This situation has not seemed to change much. At some point this leak should be addressed.

There are many toe drains on this dam, and there flows were measured as follows:

- Drain 1 – 25 gpm
- Drain 2 - drip
- Drain 3 - drip
- Drain 4 – 10 gpm
- Drain 5 - drip
- Drain 6 – 1 gpm
- Drain 7 - missing
- Drain 8 – 3 gpm
- Drain 9 – 1 gpm

The flow was 20 gallons per minute on the right side of the conduit discharge box, but I believe most of this was from the drains above it. There was just a trickle flowing from the left side of the discharge box. The flow rates are not greatly different from those measured between 2001 and 2010. The water from all toe drains dam was clean and the flow does not appear to be increasing based on the results of our previous inspections.

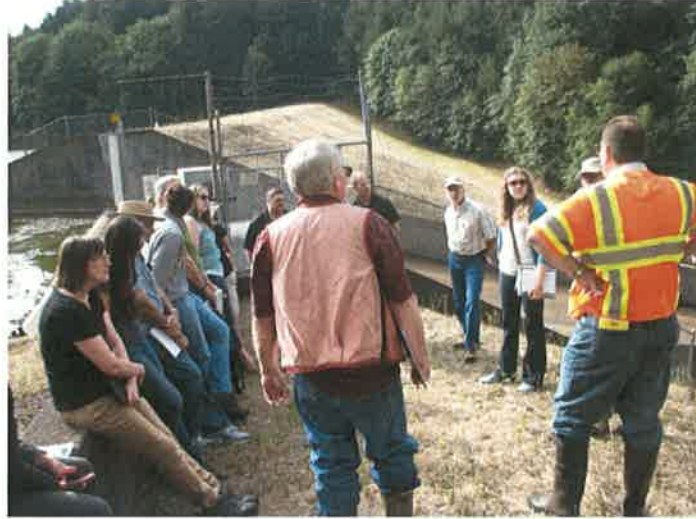
Discussion of dam safety at Silver Creek dam

We had a very good discussion of issues facing dam owners with legislative staff at the dam. The main issues are access to the dam and monitoring. Access to the dam from the south does not yet exist. The Emergency Action Plan is current as of January 2009. Overall, this dam has been well maintained and operated, and its condition has improved over the last three years.
