City of Silverton
Dept. of Public Works
306 S. Water Street
Silverton, OR 97381

July 21, 1999

**Seismic Stability Analysis
Silver Creek Dam
Silverton, Oregon**

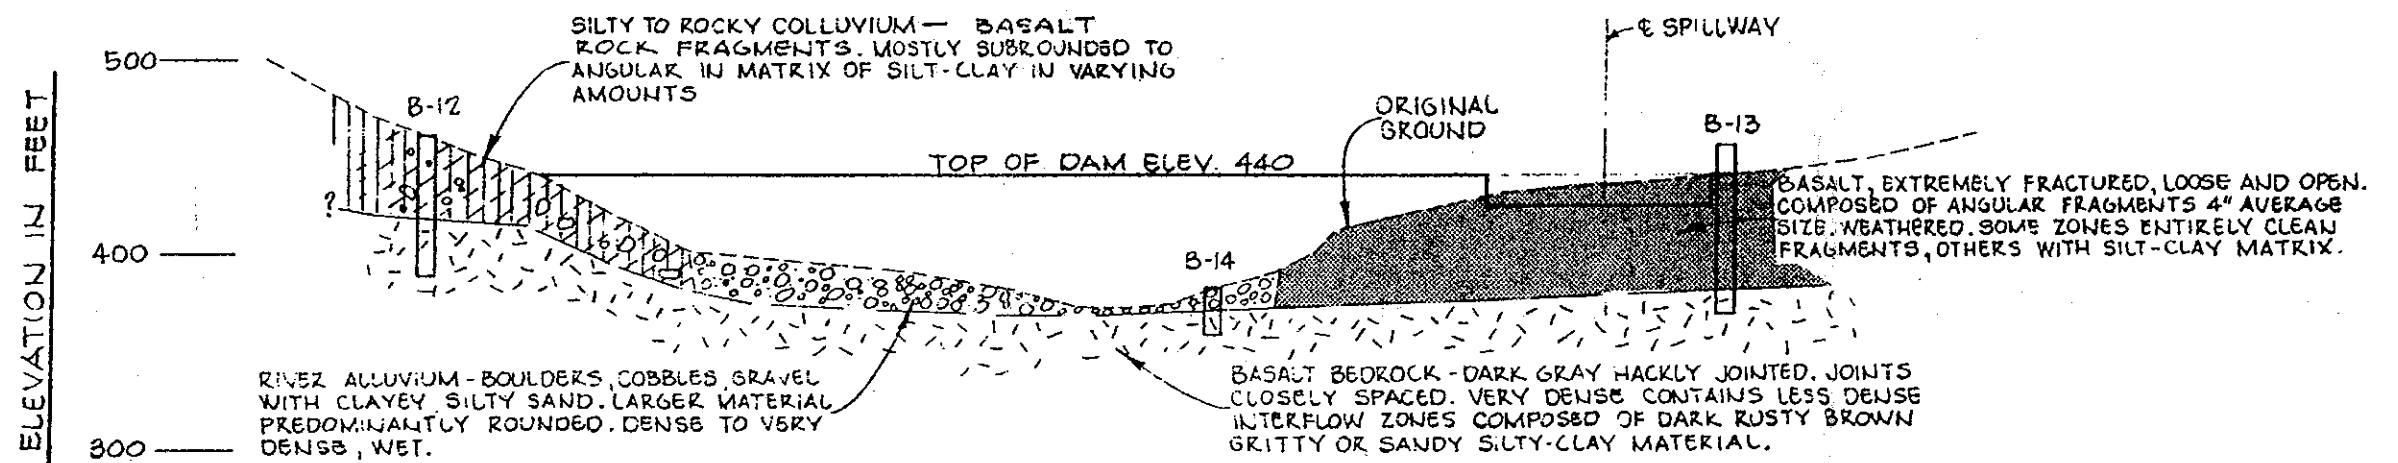
FIGURE 7
CITY OF SILVERTON, OREGON
SILVER CREEK DAM
GEOLOGIC SECTION AXIS B

Subsurface foundation conditions at Silver Creek Dam consist of colluvium and ancient landslide debris on the valley slopes, alluvial river deposits in the valley floor and Columbia River basalt bedrock in the stream bed. The left abutment contains colluvial material consisting of basalt rock fragments in a matrix of silt, sand and clay. The material was derived from weathering and erosion of the valley slopes. The thickness of colluvium varies from 10 to 50 feet near the dam site. The right abutment is ancient landslide debris consisting of angular basalt fragments and boulders with occasional silt to clay matrix. The slide debris is 80 feet thick at the right abutment. The alluvial river deposits consist of 5 to 10 feet of silty, sandy gravels and cobbles. The basalt bedrock is hard, slightly weathered and highly fractured. Basalt outcrops in the stream bed and the stilling basin at the base of the spillway is excavated into the basalt. A cross-section of the subsurface materials along the axis of the dam is shown on Figure 3.

The foundation materials consist of a thin layer of alluvium in the valley floor and colluvium and rocky slide debris on the abutments (Fig. 3). The alluvium is described as "dense to very dense", and the left abutment colluvium is described as "basalt rock fragments in a matrix of silt and clay". These materials also have a very low potential for liquefaction. The right abutment is described as "loose, angular rock fragments 4-inch average size with variable amounts of silt and clay matrix". There is a remote possibility that pockets of the right abutment could consist of loose, gravelly silt, which could be potentially liquefiable; although due to the heterogeneous nature of the right abutment (slide debris), we would not expect the potentially liquefiable pockets to be laterally continuous. Therefore, it is our opinion that lateral spreading would be minimal. Potential liquefaction-induced settlements could possibly crack the concrete spillway. However, it is our opinion that localized settlement of the spillway would not result in an uncontrolled release of water.
