February 11, 2022

Re: Silver Creek Dam (S- 66) – Inspection Summary

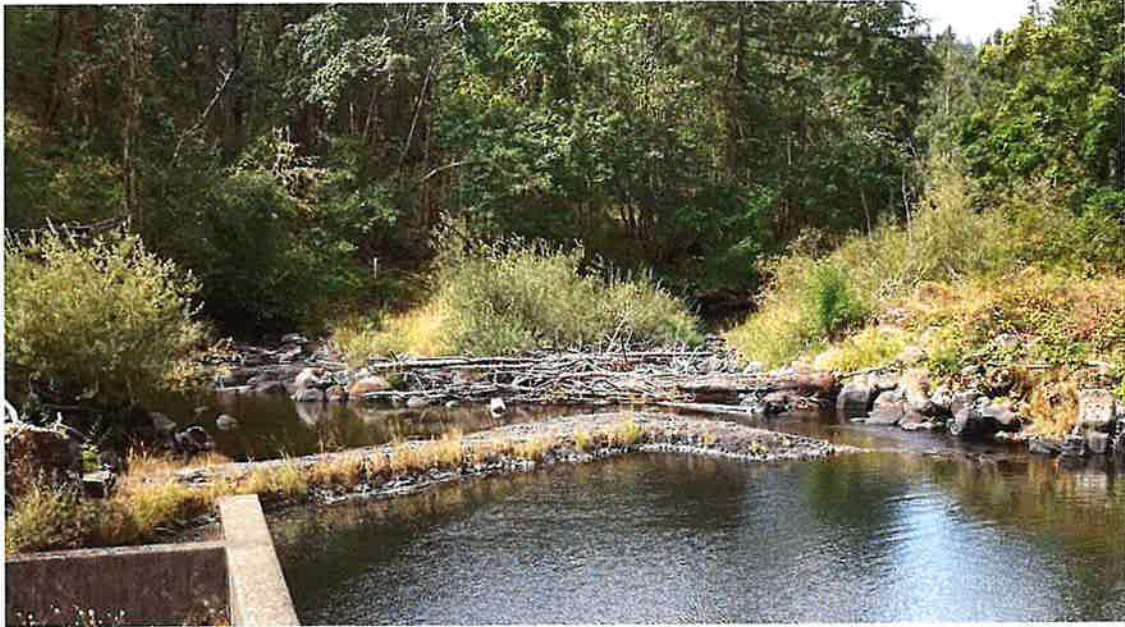
There were some large logs on the edge of the spillway discharge channel. Based on reports from staff onsite, these should wash downstream during the next heavy flow. Please monitor this area to ensure it does not become blocked.

Logs on edge of discharge channel

Discharge Channel	<input checked="" type="checkbox"/> Clear <input checked="" type="checkbox"/> Trees/brush <input type="checkbox"/> Leakage <input type="checkbox"/> Headcutting feet from spillway control section, depth: feet.) <input type="checkbox"/> None	4
Stilling basin	<input type="checkbox"/> None <input checked="" type="checkbox"/> Functional <input type="checkbox"/> Minor Erosion <input type="checkbox"/> Severe Erosion <input type="checkbox"/> Undercutting <input checked="" type="checkbox"/> No Issue	4
Aux. Spillway	<input type="checkbox"/> Yes <input checked="" type="checkbox"/> No (use "Detail" box below)	
Detail:	Concrete looks good in areas of patches. No changes since last year. Trees in spillway should wash out with next spillway flow. Monitor in case of blockage

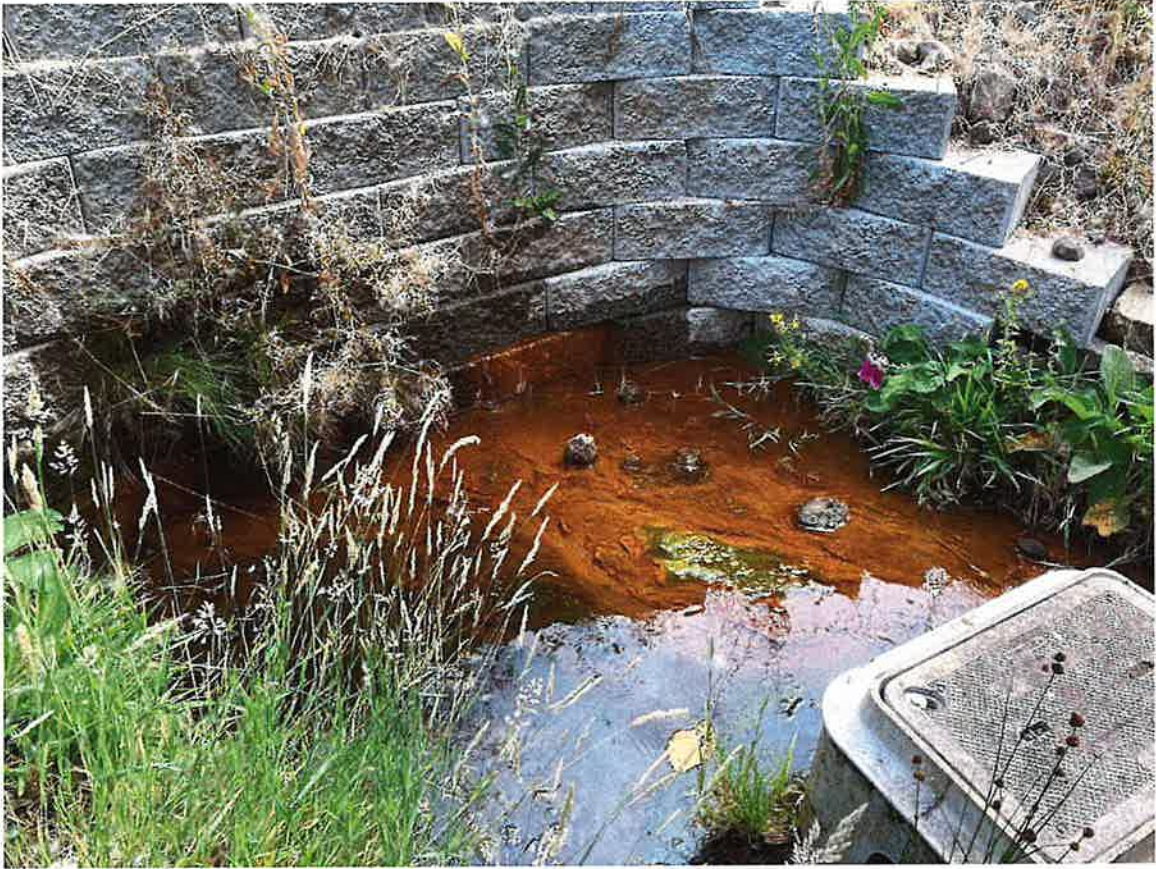
The normal seepage for this dam was observed during the inspection. There have been no significant changes in this area during the past few years. Please continue to monitor this area for any changes in flow, coloration, or sediment discharge. Because of this additional seepage, it is important to keep the weirs and toe drains clean and functioning properly. They looked great during the inspection.

Typical seepage observed at reinforced area

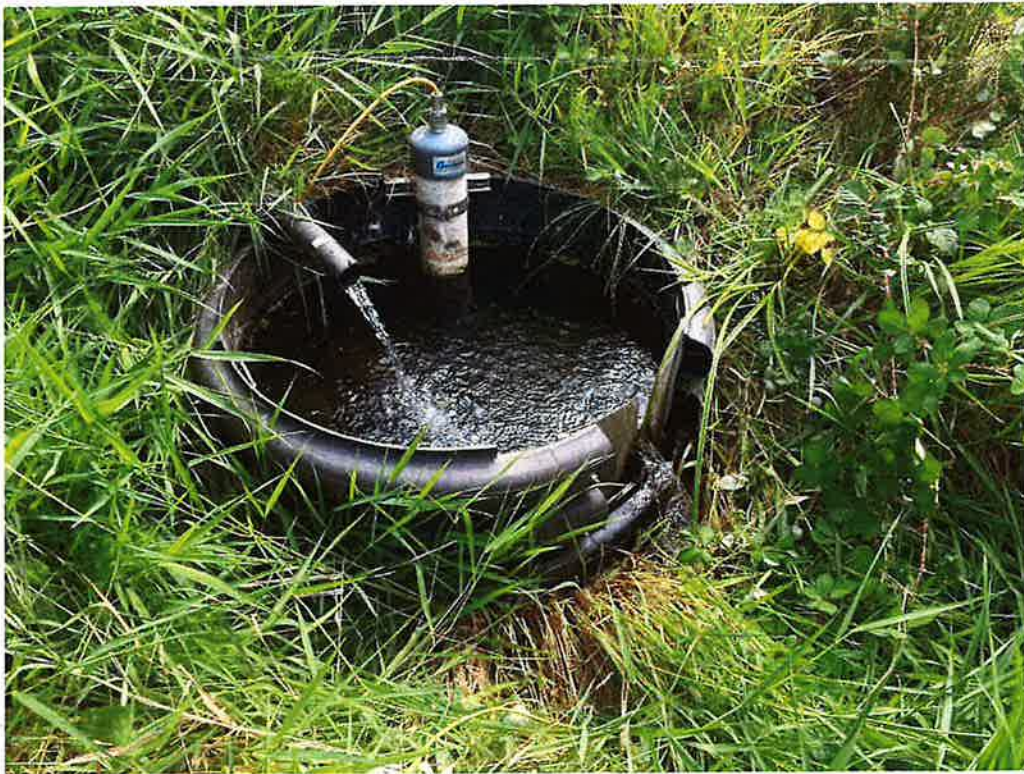
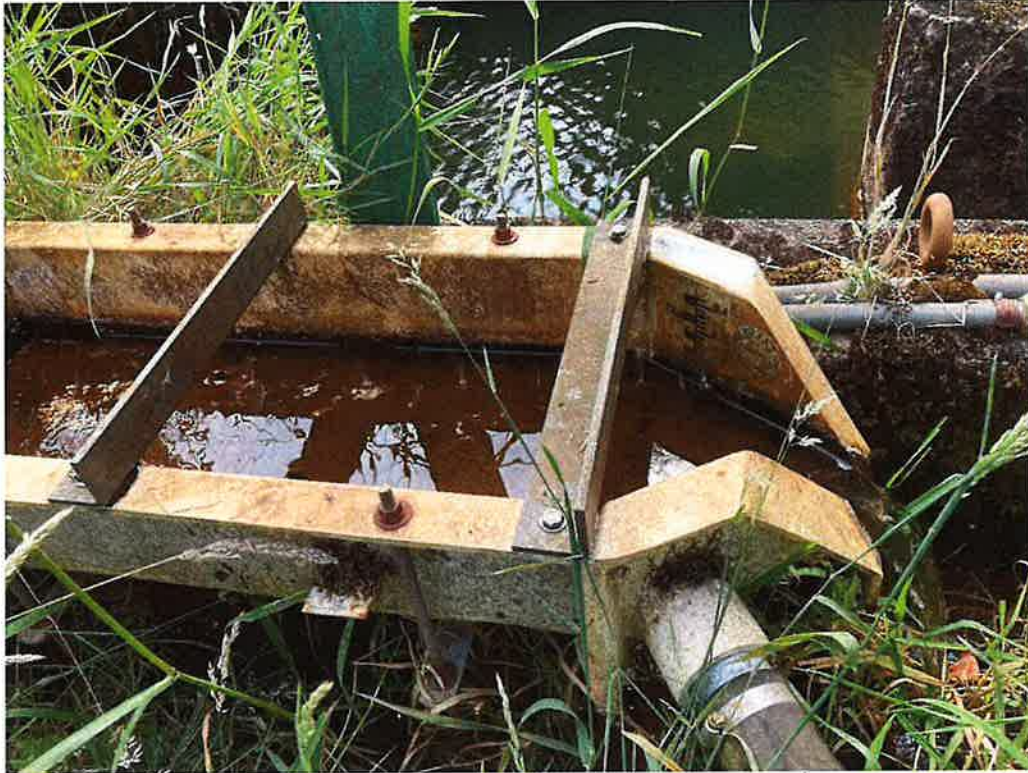
All the weirs were clean and functioning properly at the time of the inspection

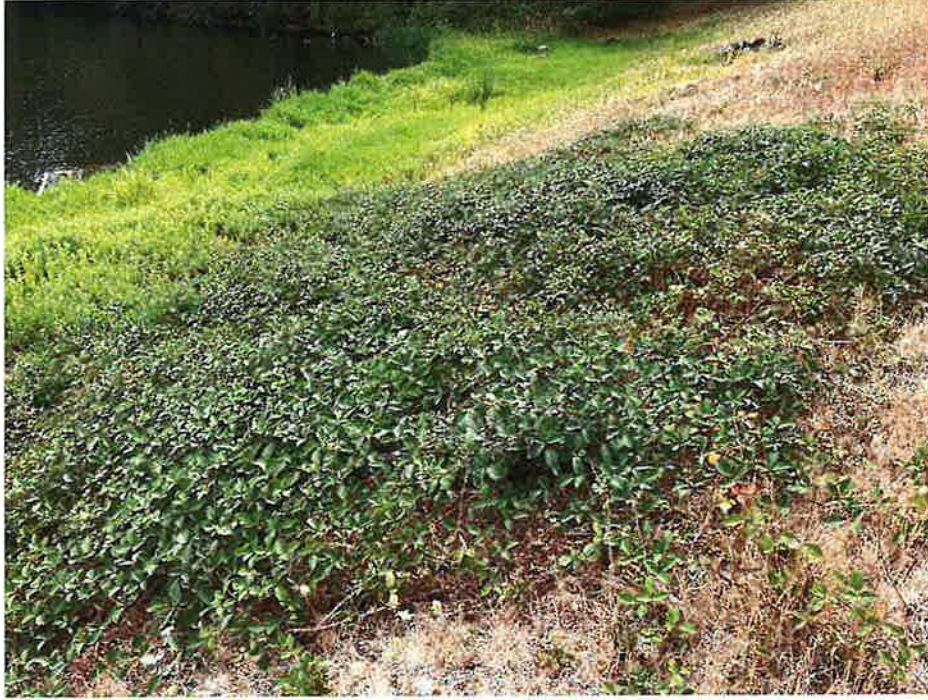
Minor maintenance is needed on the upstream side of the embankment. Some brush has grown up that should be managed to prevent habitat for burrowing animals and to enable proper inspection of the dam face. Please keep the embankment to a cover of low grass

Vegetation growing on upstream embankment and near waterline

Please manage the vegetation on the dam that has begun to grow near the waterline and on the upstream embankment. Vegetation should be maintained to a low ground cover.

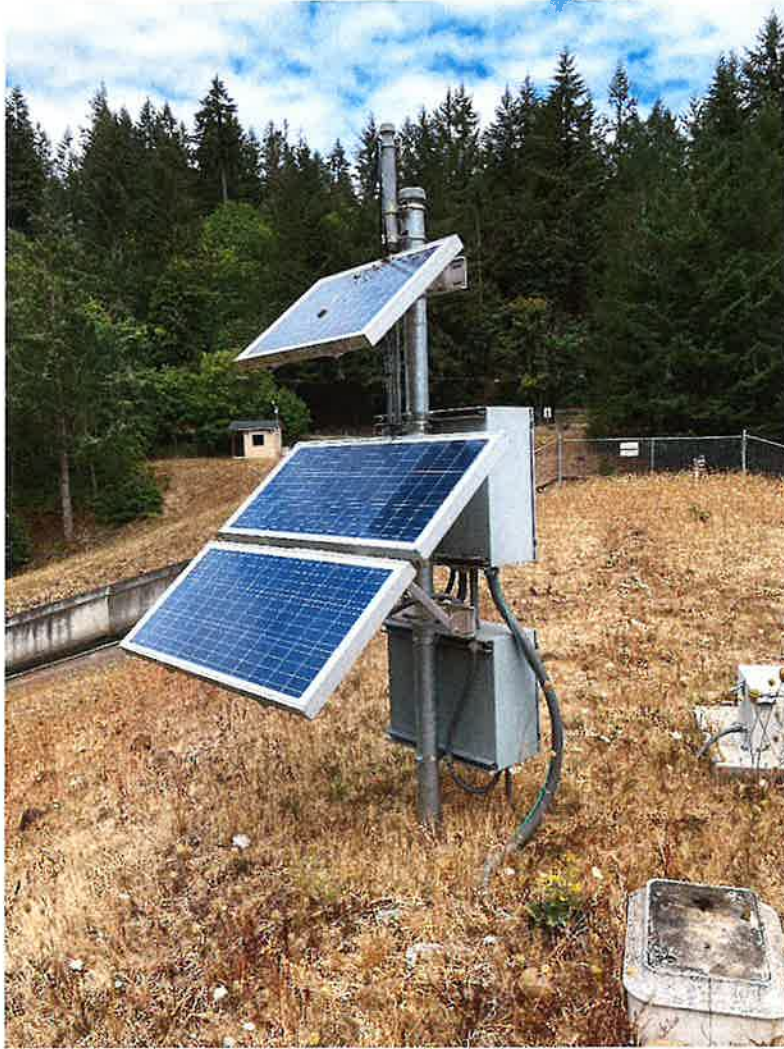
All instruments were clean and well maintained. They were all locked and secured with updates coming to the monitoring software soon.

Monitoring station, clean and secured
