CITY OF SILVERTON  
CITY COUNCIL WORK SESSION – 6:00 p.m., February 26, 2018

<b>Agenda Item No.:</b>	<b>Topic:</b>
	2.1	Discussion on Public Process for Future of Eugene Field Property
	<b>Agenda Type:</b>	
	Discussion	
	<b>Meeting Date:</b>	
February 26, 2018		
<b>Prepared by:</b>	<b>Reviewed by:</b>	<b>Approved by:</b>
Christian Saxe	Christy S. Wurster	Christy S. Wurster

1. 01/14/2014 Facility Evaluation – ZCS Engineering Inc.

## Silver Falls School District

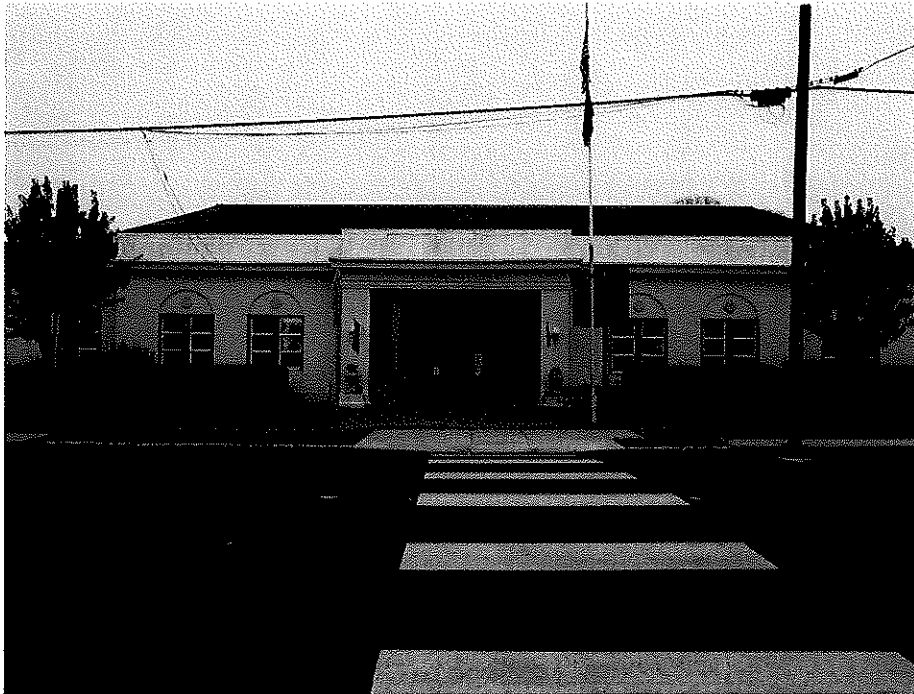
Figure 3: Classroom Wing Front Elevation

The classroom wing of the original structure is a single story building with an approximate footprint of 17,770 square feet (Figure 3 – Classroom Wing Front Elevation). The building currently houses classrooms, the school office, principal's office, storage, and restrooms.

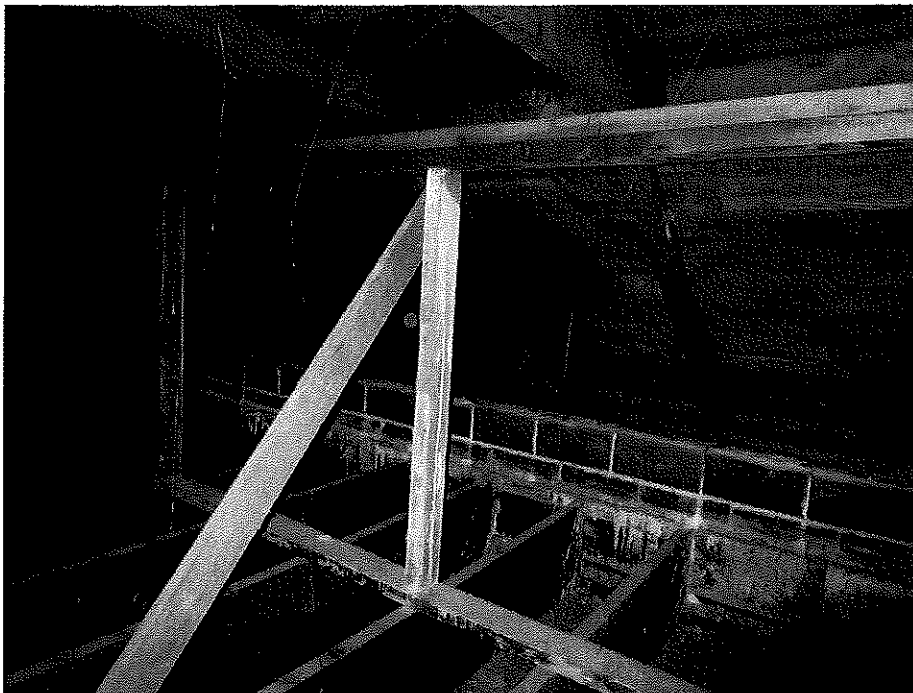
Figure 4: Typical Classroom Framing

The structure's gravity load elements bear on a cast-in-place concrete foundation around the perimeter and a post and beam system with dimensional lumber floor joists and concrete footings between bearing lines within the building footprint.

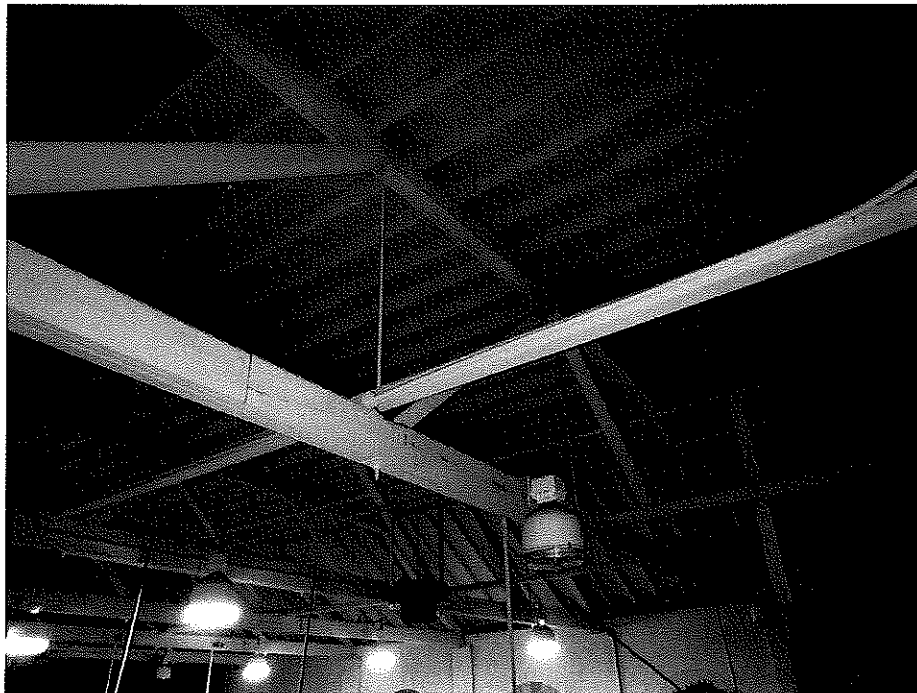
Figure 6: Gymnasium Framing

Building B is framed with built-up dimensional lumber roof trusses that are suspect. These roof trusses have long spans, carry heavy loads, and their connections appear to be inadequate.

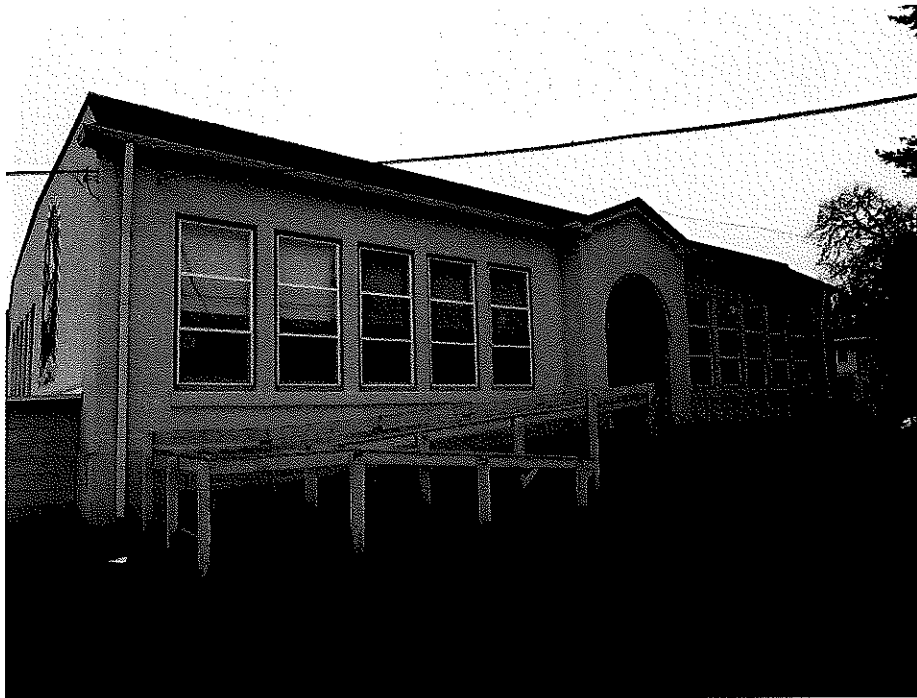
Figure 7: Classroom Wing Addition

Two additional classrooms, which are not depicted in the original construction documents, are present at the end of the structure. Typical evidence of building addition efforts were not observed suggesting that the floor plan may have been expanded during construction and not formally documented upon completion.

The foundation consists of concrete footings, stemwalls, and at the basement, concrete retaining walls. The basement floor is slab-on-grade, while the upper story and remainder of the addition are constructed with a post and beam system and dimensional lumber floor joists similar to the original building.

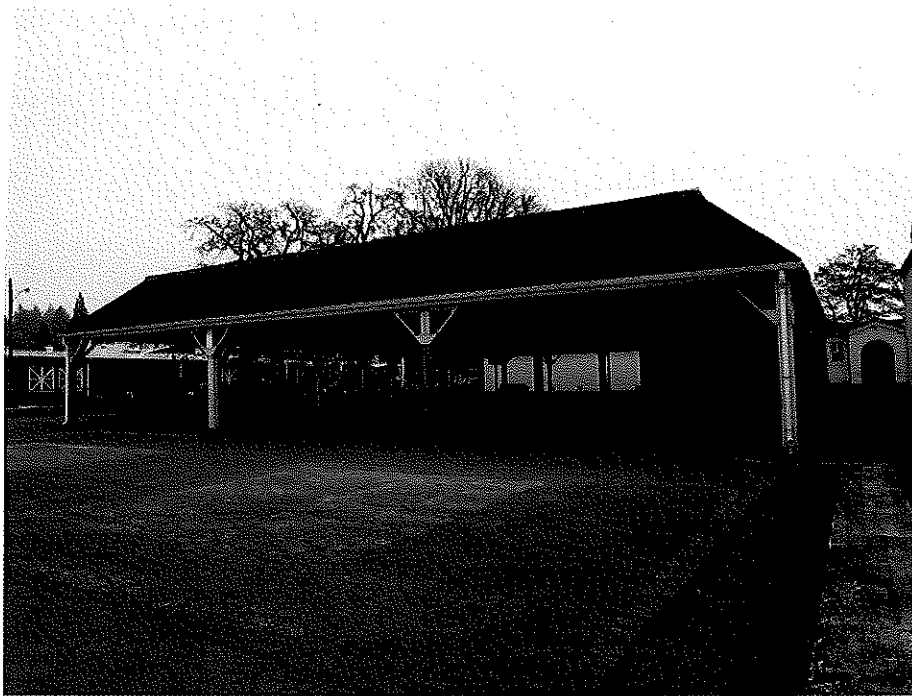
Figure 9: Covered Play Area

The covered play structure is approximately 9,380 square feet in area and is located roughly 12-feet northeast of the gymnasium (Figure 9 – Covered Play Area). One corner of the play structure is in-filled with wood studs between post bays, creating a storage shed.
